A Root Cause Study to Determine the Source of High Gypsum Moisture

**Jamie L. Mion,
Michael T. Hoydick,
Stephen E. Winter;**
*Foster Wheeler North
America, Pittsburgh, PA*

Presented at
Power Plant Pollutant Control MEGA Symposium
August 19-21, 2014
Baltimore, MD, USA

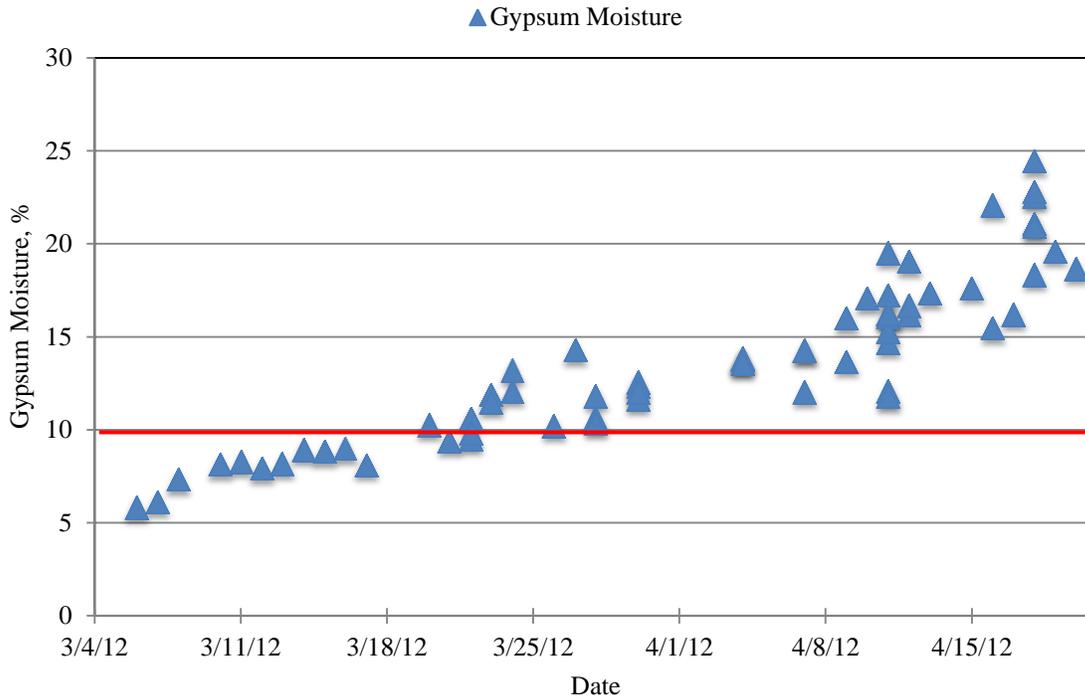
At Plant A, Unit 56 and Unit 78 Absorber startups were staggered by three months. During the initial Unit 56 start-up, the gypsum filter cake became increasingly difficult to dewater. Gypsum moisture values exceeded the 10% maximum specification after only two weeks of dewatering operation. By the seventh week, moisture had continued to increase and surpassed 20%. This is illustrated in Figure 1.

Figure 1. Unit 56 Initial Gypsum Moisture Excursion

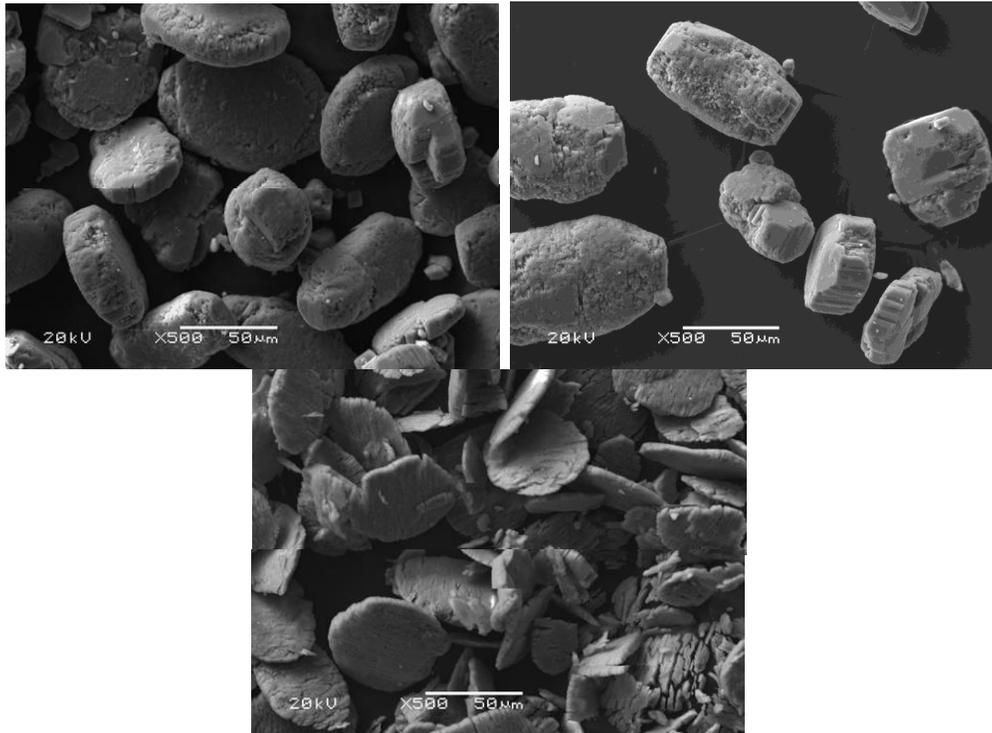
Initial investigations focused on a number of equipment and process possibilities, including poor vacuum filter performance, improperly tuned hydroclones, absorber operating density, limestone quality and water quality. Pictures of the gypsum crystals taken by SEM (Scanning Electron Microscope) provided the first insight into the issue. Typical WFGD gypsum crystals appear block-like in shape and have a distinct structure, but the Plant A gypsum crystals appeared as flat, plate-like crystals with irregular edges. These flat crystals were exceptionally difficult to dewater because they created an impervious filter cake that prevented the extraction of moisture. Figure 2 compares typical FGD gypsum crystals with the irregular crystals from Plant A.

Figure 2. SEM Photographs of Gypsum Crystals
Typical Gypsum Crystals (Top), Plant A Gypsum Crystals (Bottom)

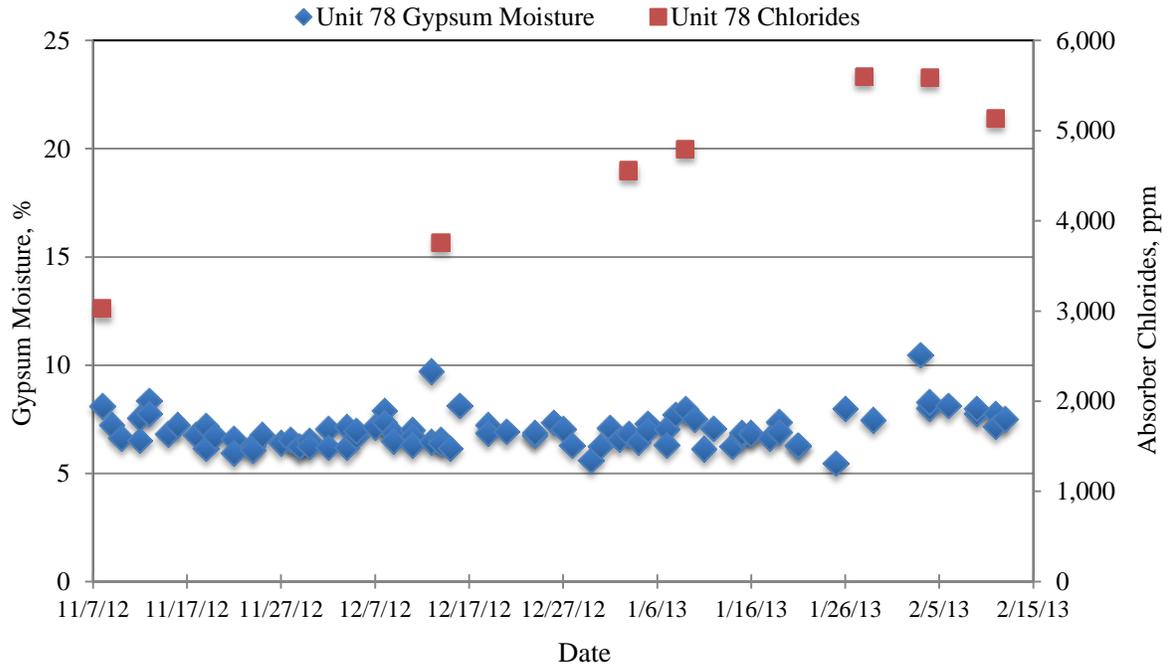
Surprisingly, the Unit 78 gypsum moisture values did not exceed the specification limits during the test plan even under the most concentrated conditions, as shown in Figure 3.

Figure 3. Results of Stage 1 Test

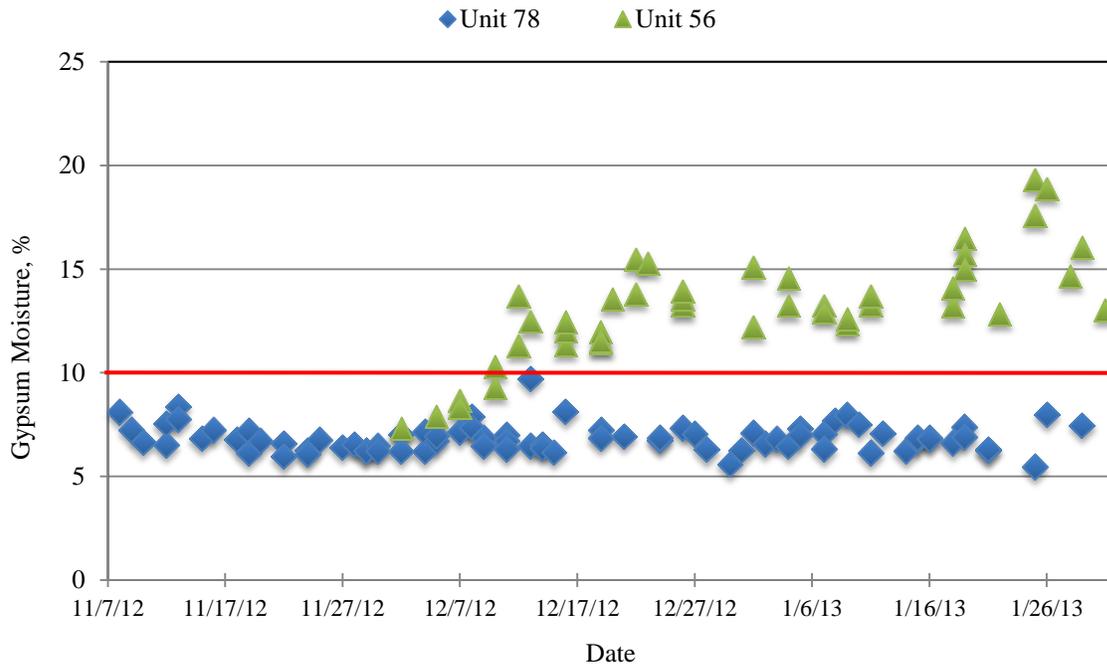
After the onset of the testing on Unit 78, Boiler Units 5 and 6 returned to service and resumed operation under normal AQCS conditions. Gypsum moisture excursions returned to the Unit 56 system but were absent on Unit 78, even though Unit 78 was operating with increased concentrations of dissolved species. See Figure 4.

Figure 4. Unit 56 & 78 Gypsum Moisture during Stage 1 Test

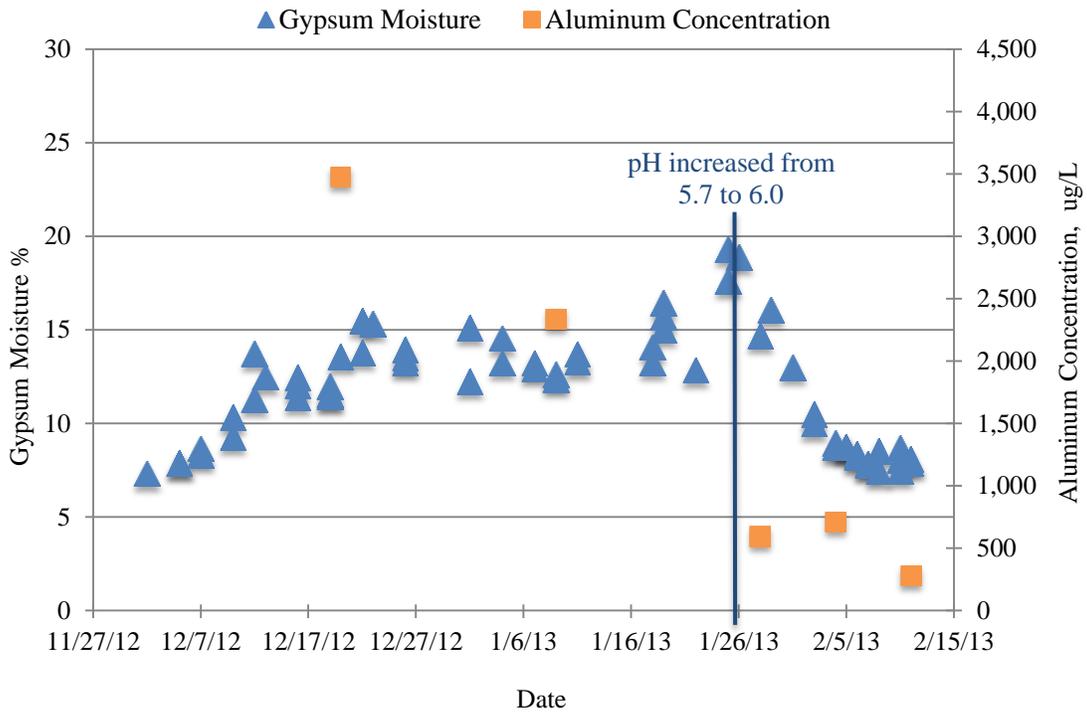
Test data showed that aluminum was an element that trended well with Unit 56 gypsum moisture. Figure 5 shows increased aluminum concentrations were observed during gypsum moisture excursions. It also shows that increases in pH reduced the liquid phase aluminum concentration, which subsequently improved gypsum moisture.

Figure 5. Unit 56 Gypsum Moisture and Aluminum Concentration in Relation to pH

To improve the gypsum quality, an operational remedy was implemented that required no changes to the inlet flue gas. It was shown that operation of the absorber at a pH of 6.0 or above would generally reduce gypsum moisture below 10%. However, this typically resulted in gypsum purity falling below the 95% minimum specification due to the presence of elevated residual limestone (CaCO_3). To find a balance between moisture and purity, the plant operated with modified pH control. The pH was set to 6.0 while the density of the absorber was low and the gypsum crystals were forming. The pH was then lowered to 5.7 several hours before dewatering commenced so that the unreacted limestone in the system could be consumed by system chemistry demands. After dewatering was completed, the pH was returned to 6.0. This operating method proved relatively successful in maintaining quality gypsum with acceptable free moisture.

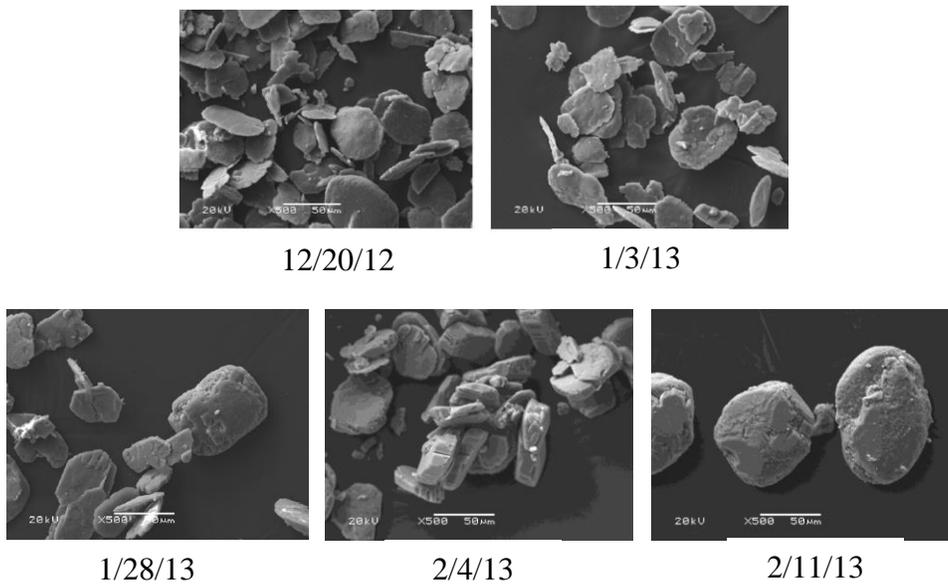
The improvement in gypsum moisture after the pH change corresponded to an improvement in gypsum crystal morphology. Initially plate-like crystals became thicker and more defined after the pH increase and subsequent drop in liquor phase aluminum concentrations. Figure 6 shows gypsum SEM photographs corresponding to the dates in Figure 5.

Figure 6. Unit 56 Gypsum SEM Photographs Corresponding to Figure 5

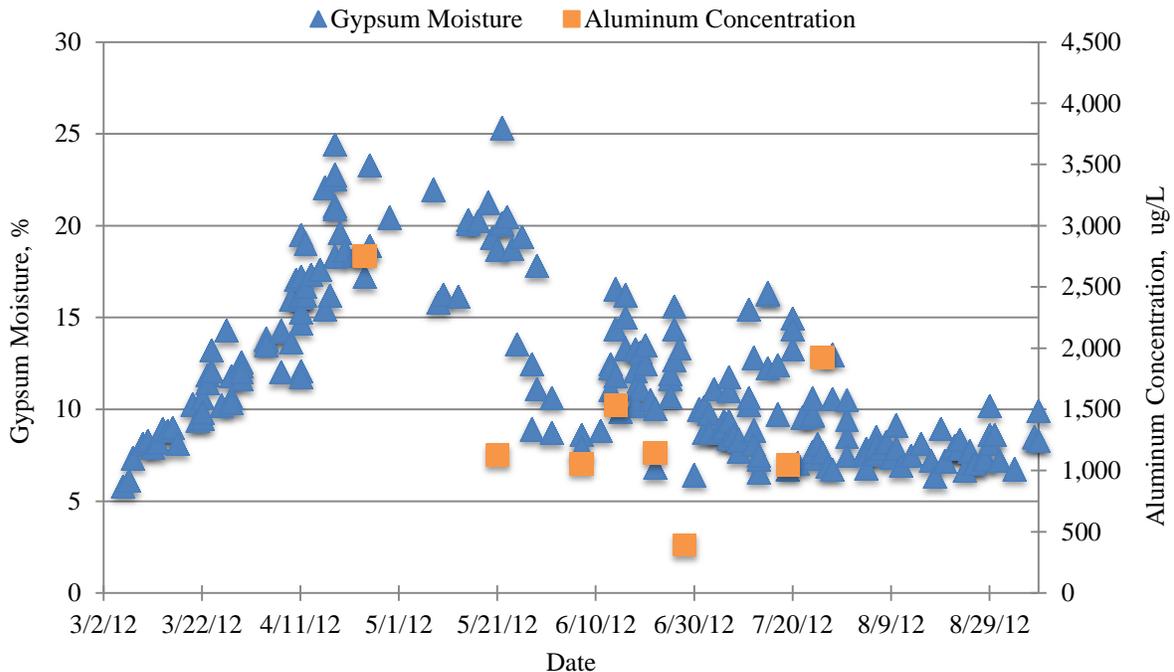
Review of all data collected from Unit 56 showed that the aluminum and gypsum moisture trend existed prior to the Stage 2 study, as seen in Figure 7. For clarity, pH changes were omitted from this chart.

Figure 7. Unit 56 Gypsum Moisture and Aluminum Concentration
